**MH17**

**The Open Source Evidence**

A bellingcat Investigation

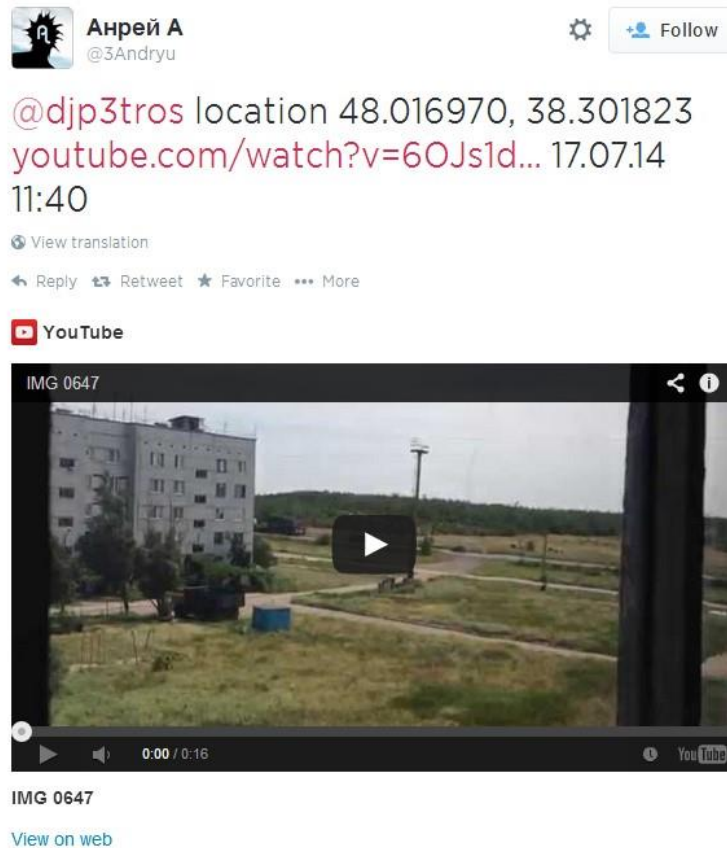
The image shows a screenshot of a tweet from the user Андрей A (@3Andryu). The tweet text reads: "@djp3tros location 48.016970, 38.301823 youtube.com/watch?v=6OJs1d... 17.07.14 11:40". Below the text are options for "View translation", "Reply", "Retweet", "Favorite", and "More". A YouTube video player is embedded in the tweet, showing a video titled "IMG 0647". The video player interface includes a play button, a progress bar at 0:00 / 0:16, and a "View on web" link below the player.

The coordinates were confirmed as being correct, and the location was later visited by teams from ARD TV,<sup>8</sup> Correctiv,<sup>9</sup> and 60 Minutes Australia,<sup>10</sup> all of whom confirmed the location was correct.

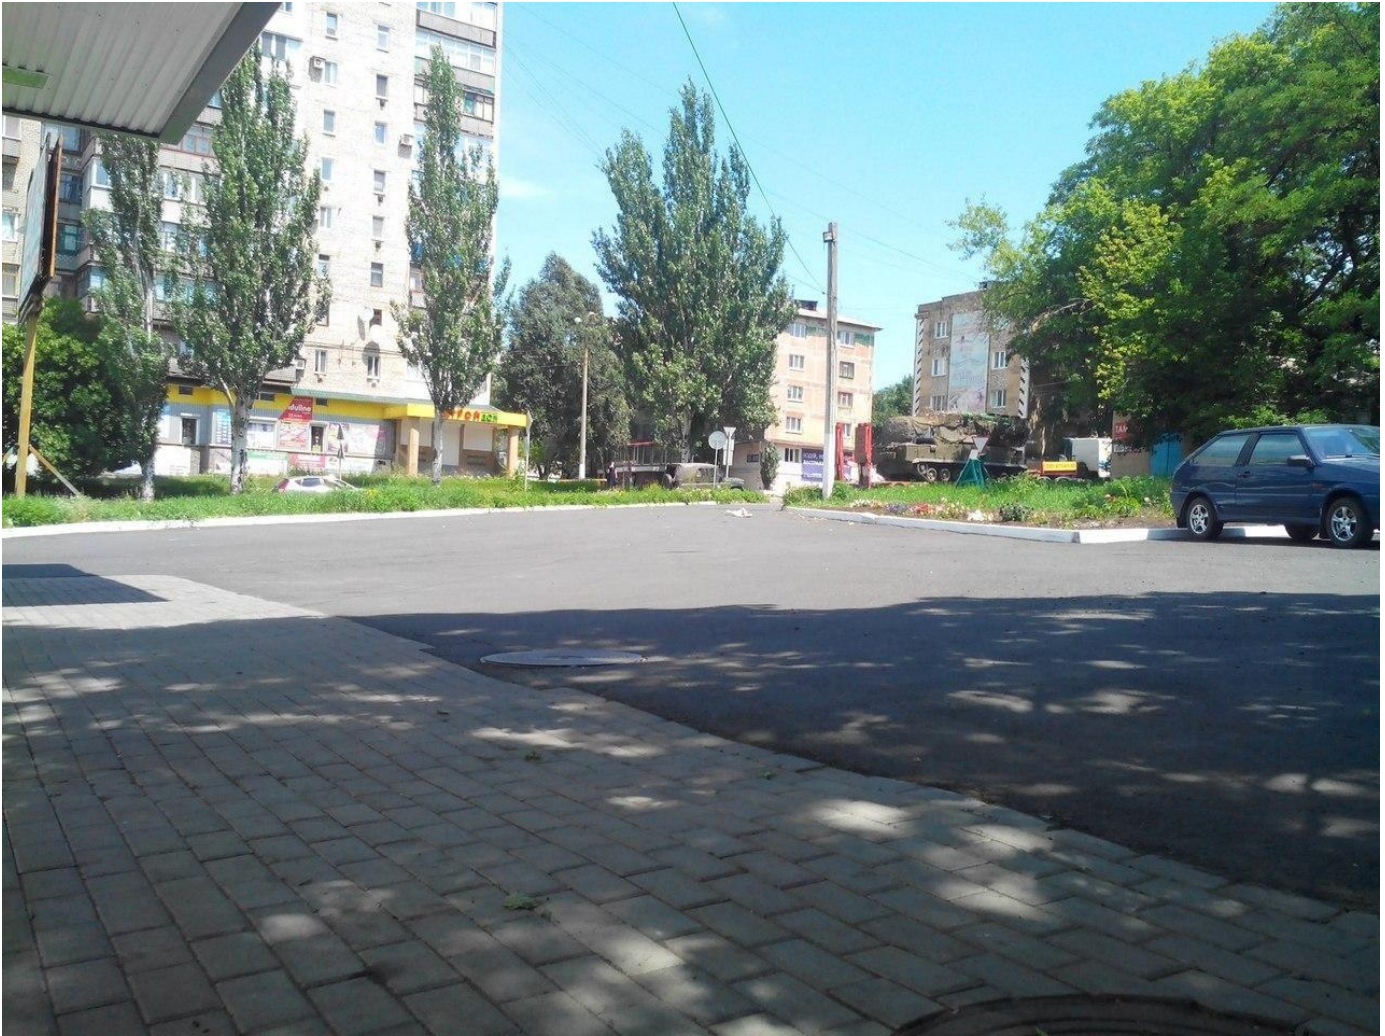
Just after midday, posts were made on social media sites<sup>11</sup> about a Buk missile launcher being transported through the town of Torez, east of Zuhres, and a photograph of the Buk missile launcher being transported by the same missile low-loader seen in the previous images was posted online several hours later. This photograph was geolocated to Torez,<sup>12</sup> with the location again confirmed by ARD TV, Correctiv, and 60 Minutes Australia. As with the Donetsk photographs, camouflage netting can be seen covering the missile loaded onto the Buk.

It was also possible to estimate the time the photograph was taken based on the position of the shadows, which showed that the time was around 12:30 pm. Journalists from the Guardian (UK)<sup>13</sup> and BuzzFeed<sup>14</sup> visited the site a few days after July 17 and confirmed this timeframe with locals who had witnessed the Buk missile launcher traveling through the town just after noon.

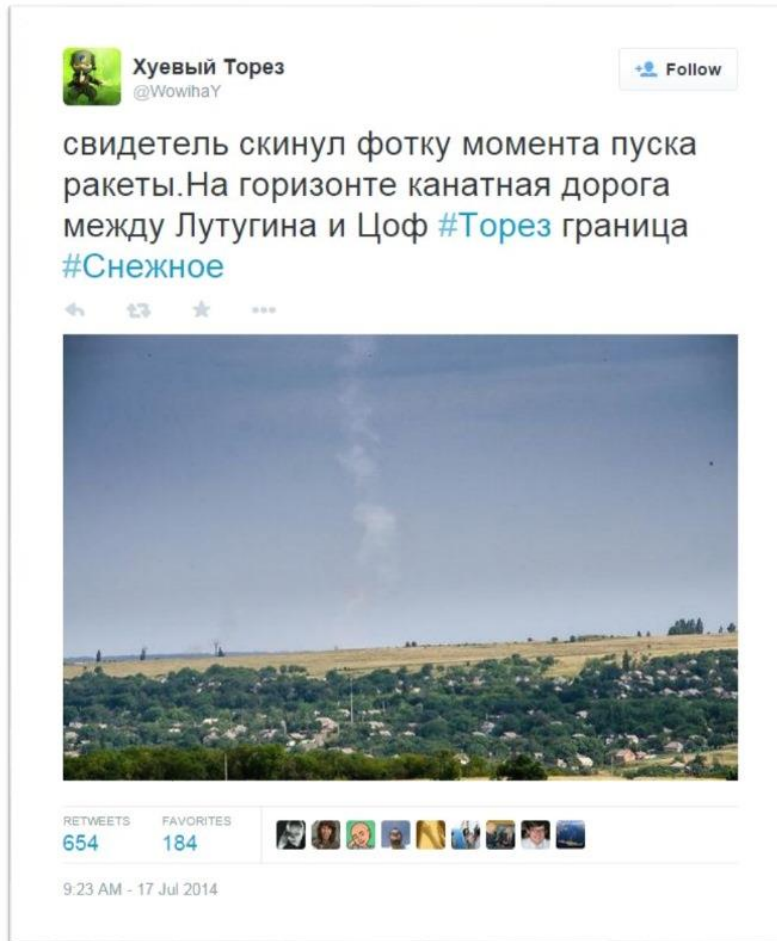
A few hours after MH17 was shot down, a photograph was shared on Twitter<sup>17</sup> claiming to show the smoke trail from the launch of the missile that shot down MH17.

Dutch news outlet RTL Nieuws conducted an interview<sup>18</sup> with the photographer of the white smoke trail in December 2014, and two research organizations, Fox-IT and NIDF, verified the authenticity of the photographs, while two other organizations, NEO and the Delft University of Technology (TU Delft), examined the white smoke trail and geolocated the photographs. Bellingcat and others also geolocated the photographs,<sup>19</sup> and the exact direction from which the smoke originated.

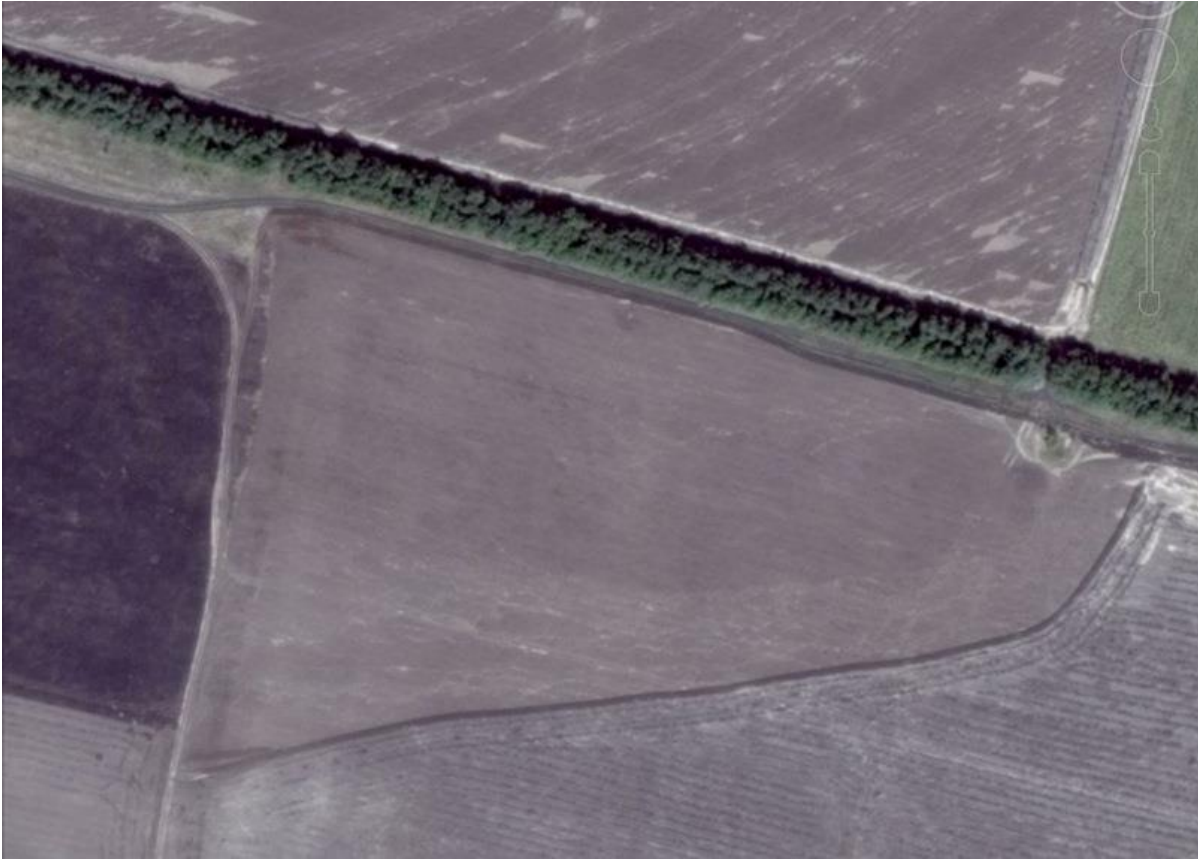
Oliphant and Miller discovered one field where a corner had been burnt over a wide area. He took a number of photographs, which were subsequently used by the Ukraine@War blog<sup>23</sup> to geolocate the exact location of the field. This geolocation, which has been reviewed and confirmed by the Bellingcat investigation team and personally confirmed by Roland Oliphant, points to a field just south of where the tracks were visible on the July 20, 2014 satellite map imagery.

This location is in line with the smoke seen in the photograph posted on Twitter and verified by experts as authentic.

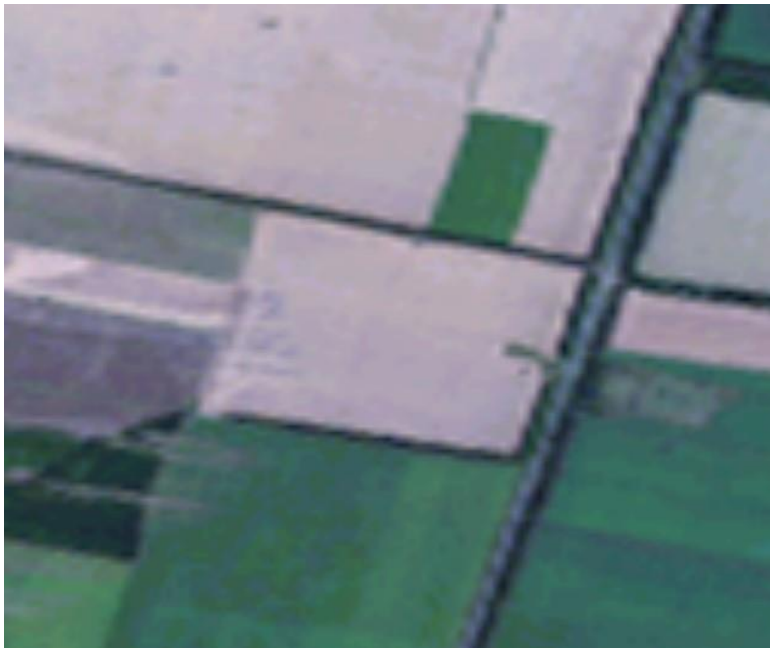
Digital Globe satellite imagery of the area shows that the burnt/plowed area in the northwest corner of the same field was absent the day before, on July 16, 2014.<sup>24</sup>

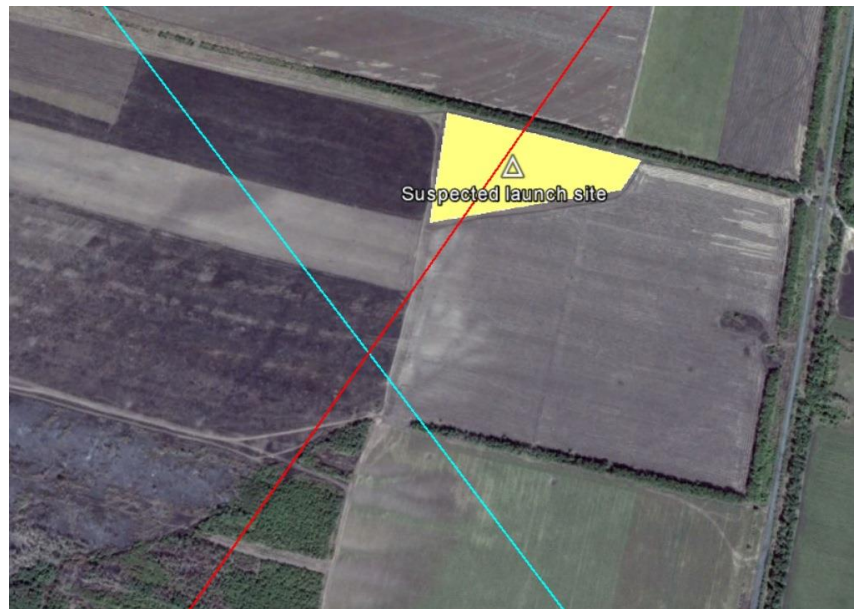
Using geographical landmarks in the US imagery, it was possible to identify the same landmarks in Google Earth satellite imagery, and from that determine the launch location. The image below shows origin point in the US imagery in relation to the field visited by Oliphant and Miller, which, again, is in line with the smoke in the photograph posted on Twitter.

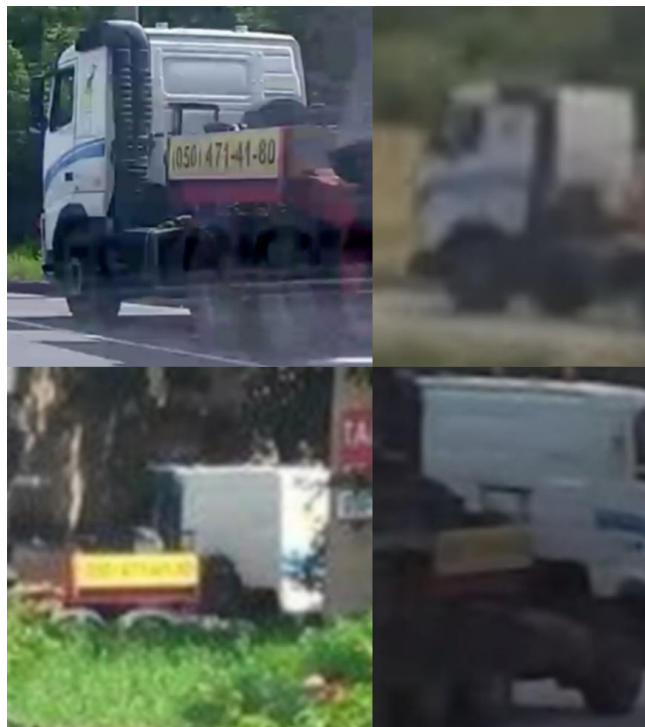
Clockwise from top left – Donetsk, Zuhres, Luhansk, Torez

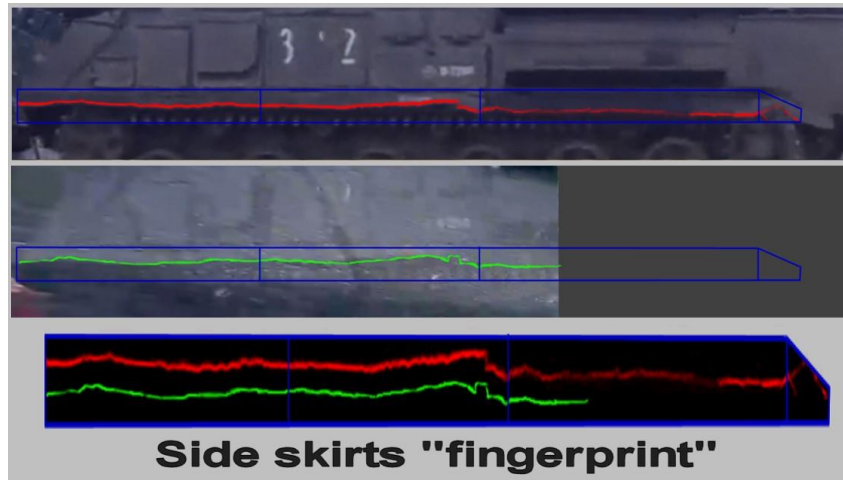
A burn mark above the exhaust visible in one of the Paris Match photographs was also in exactly the same position as the one seen on Buk 3x2 in Russia. While all of these pieces of evidence seemed to indicate that the Buk in Ukraine and Buk 3x2 were one and the same, an additional piece of evidence made the case particularly compelling. During Bellingcat's research<sup>40</sup> into the many Buk sightings, it became clear that the rubber side skirt above the tracks of Buk missile launchers can become damaged over time and that this damage creates a unique "fingerprint" allowing different Buk photographs to be matched. In the case of Buk 3x2 and the Buk photograph by Paris Match in Donetsk, the side skirts were nearly identical.

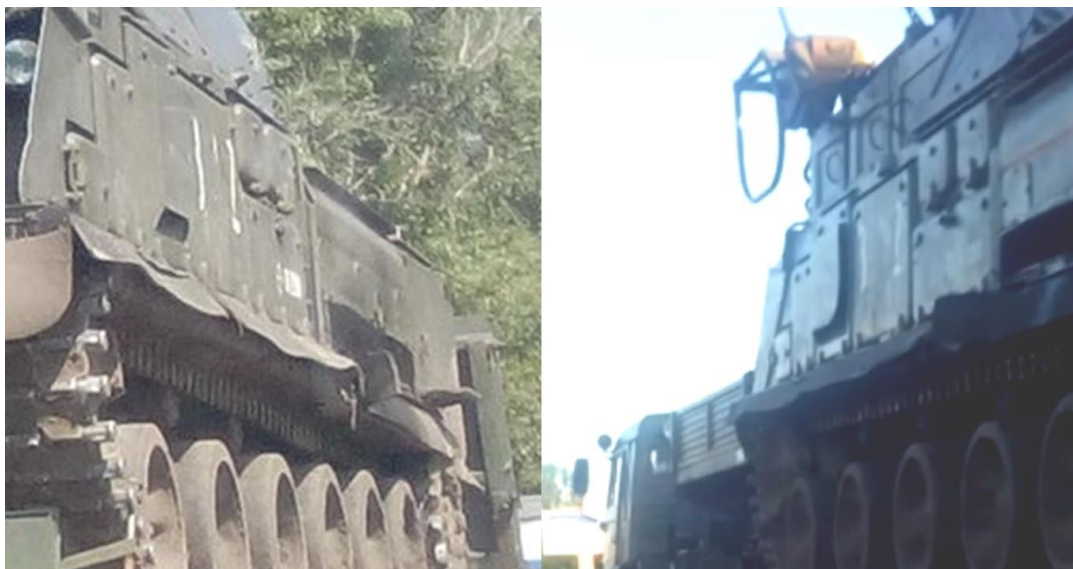
However, there was one major discrepancy. A kink in the side skirt, visible around two-thirds of the way from the left, did not match. This could be explained two ways: either the side skirt was different, or the process of flattening the Donetsk image to compare to the Buk 3x2 image was unable to factor in significant three-dimensional damage to the skirt. Additional images of Buk 3x2 in Russia confirmed that there was in fact a large tear in the side skirt, bending it outward in exactly the same position as the discrepancy in the comparison.

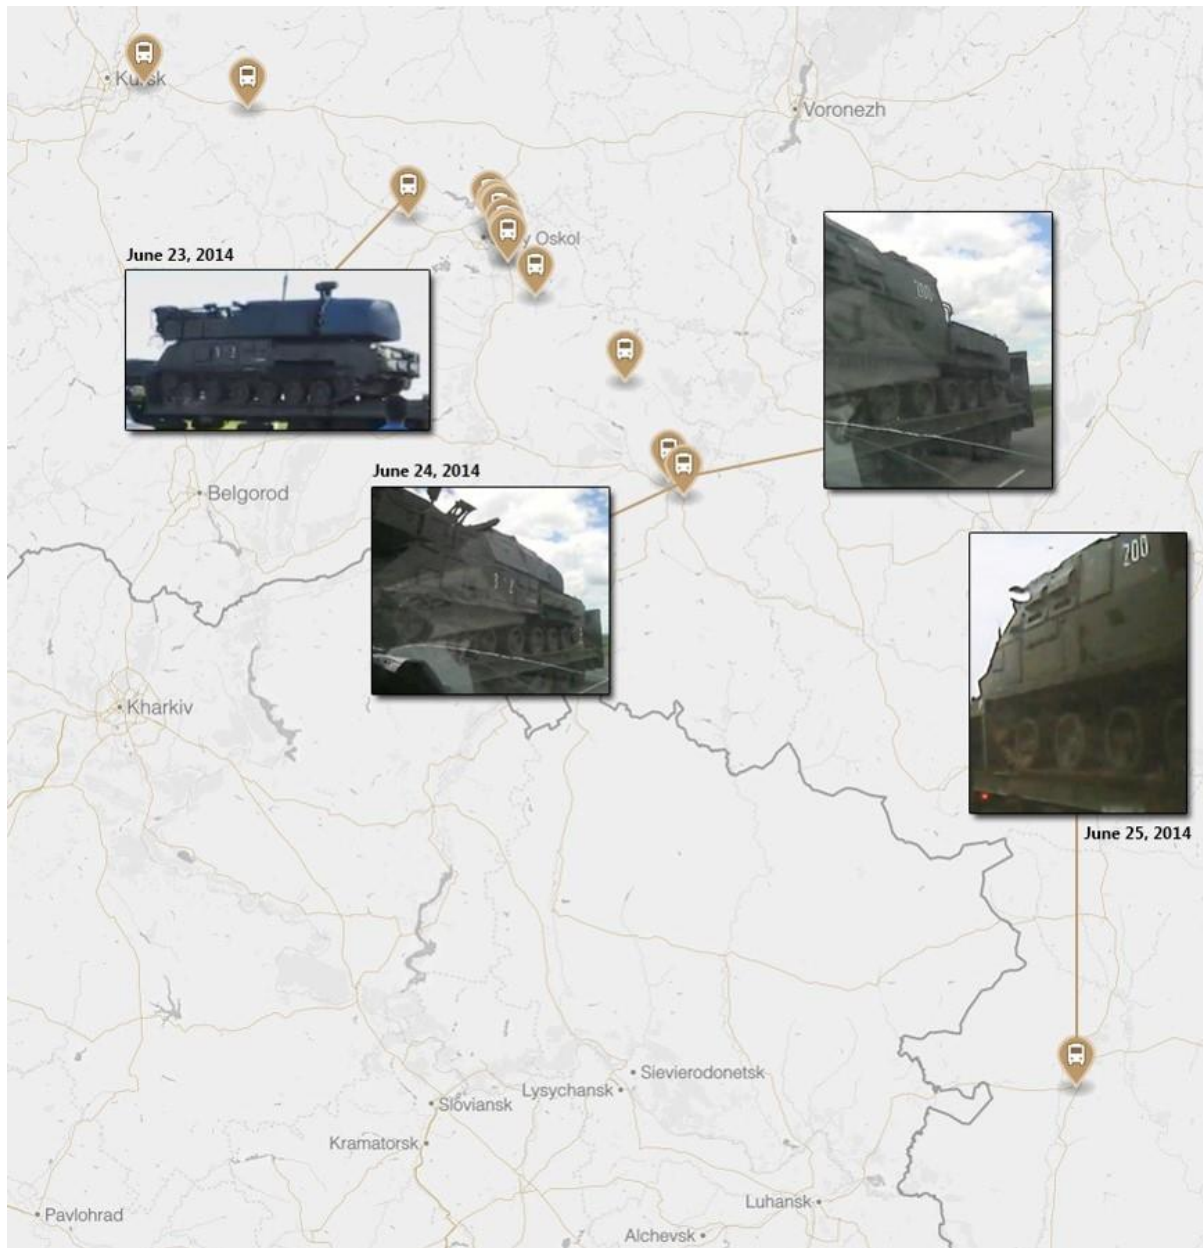
Buk 3x2 was identified as being part of a military convoy that travelled from Kursk to Millerovo, Russia, between June 23 and June 25. Multiple photographs and videos of the convoy, shared online by Russian civilians who lived along the convoy's route, were identified. Each image was geolocated to the exact location it was recorded, providing an accurate representation of the route that the convoy traveled.

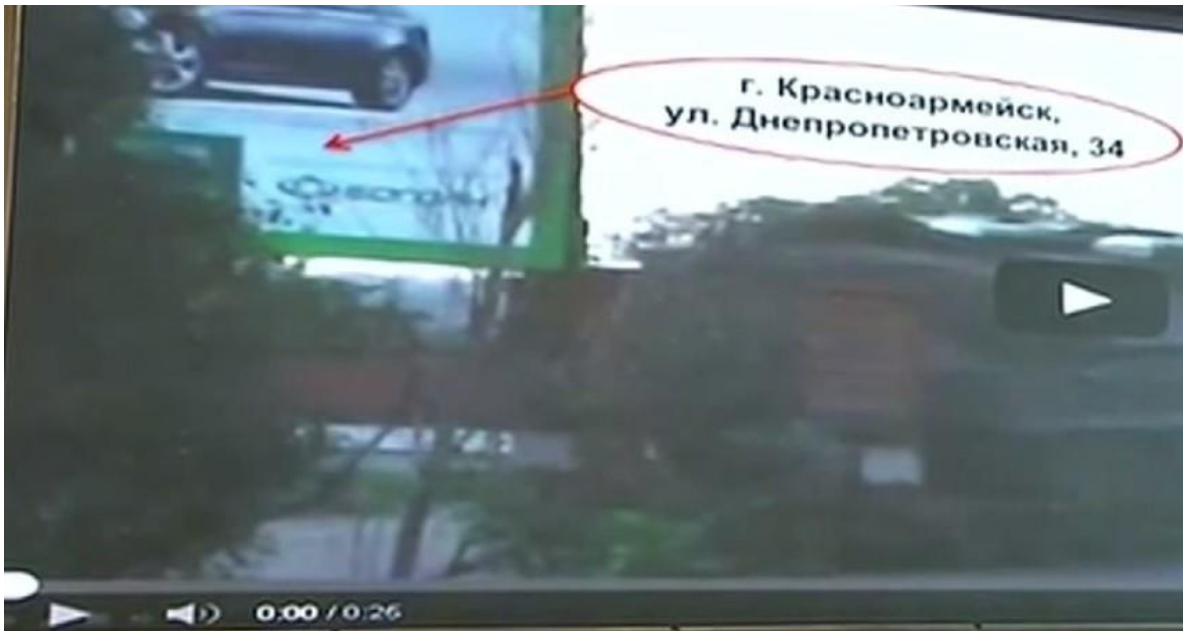
To support this claim, they provided an image of the billboard visible in the video along with what they claimed the line of text read.

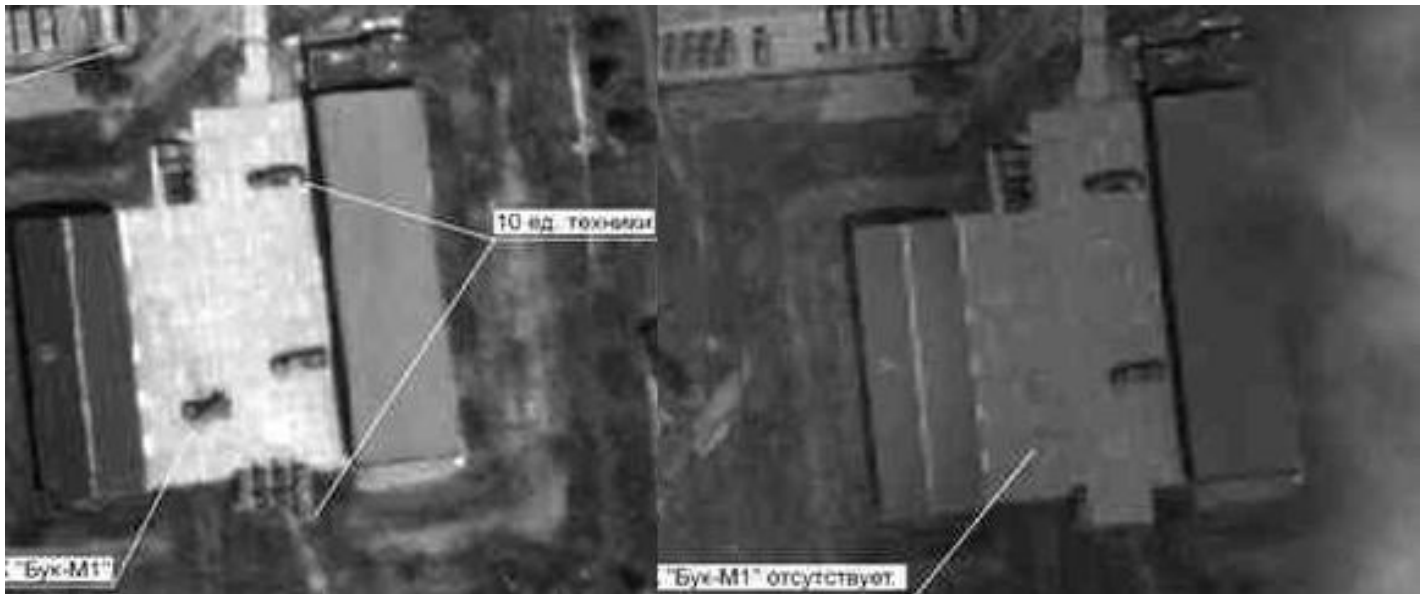
Russia also presented sets of satellite imagery showing three different locations, including two military bases and a field outside the town of Zaroshchens'ke. At one military base, the 1428, it was claimed that images from July 14 and July 17 showed that a Buk missile launcher had moved from the base on July 17.

However, comparisons of an image from the satellite company Digital Globe of the same location on July 17<sup>49</sup> show a number of clear discrepancies. For example, large areas of vegetation visible in the July 14 Ministry of Defense images were absent from the July 17 Digital Globe image.

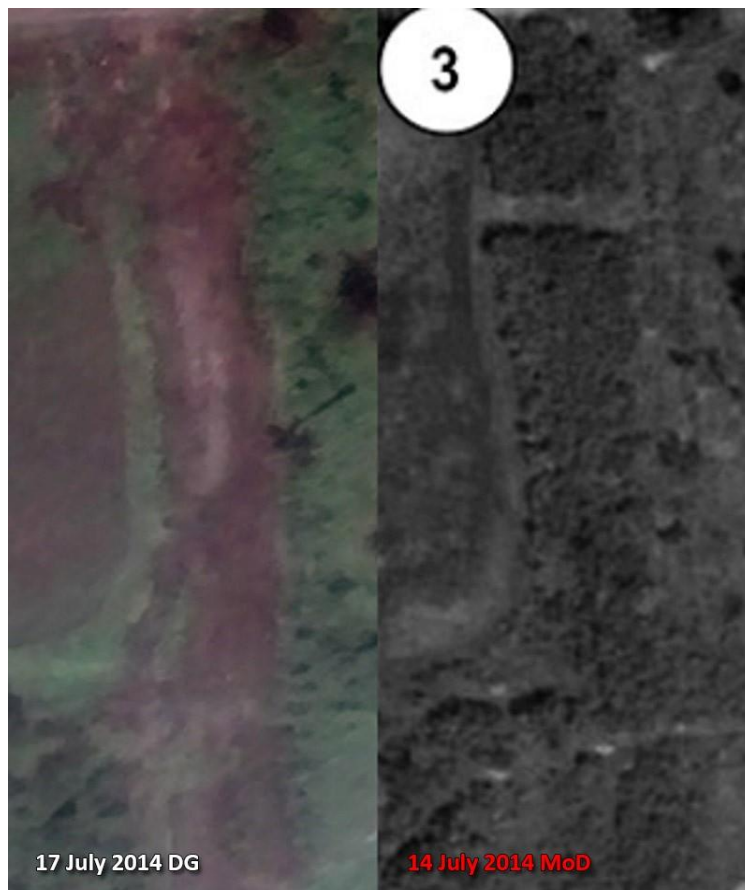
Historical satellite imagery of the same location from July 2 and 21 of the same area on Google Earth confirms that the vegetation had been cleared weeks before July 17.

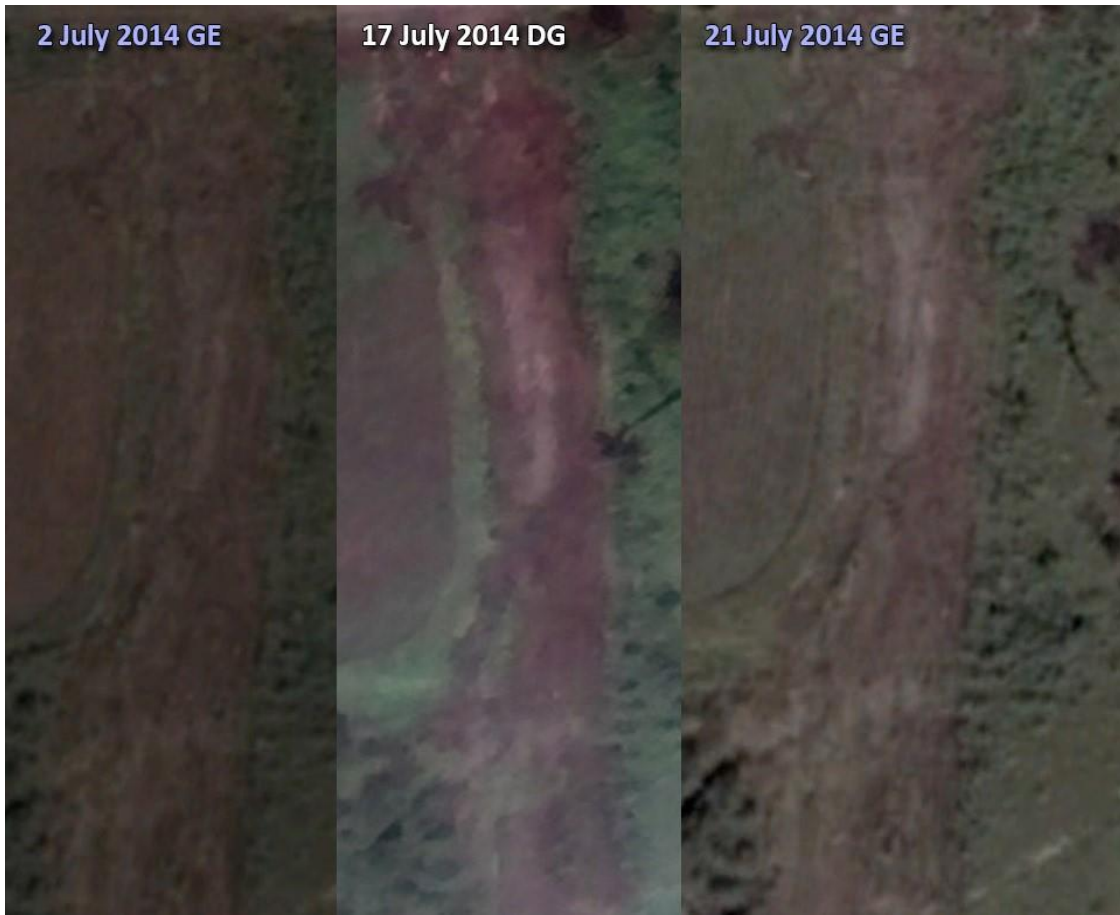
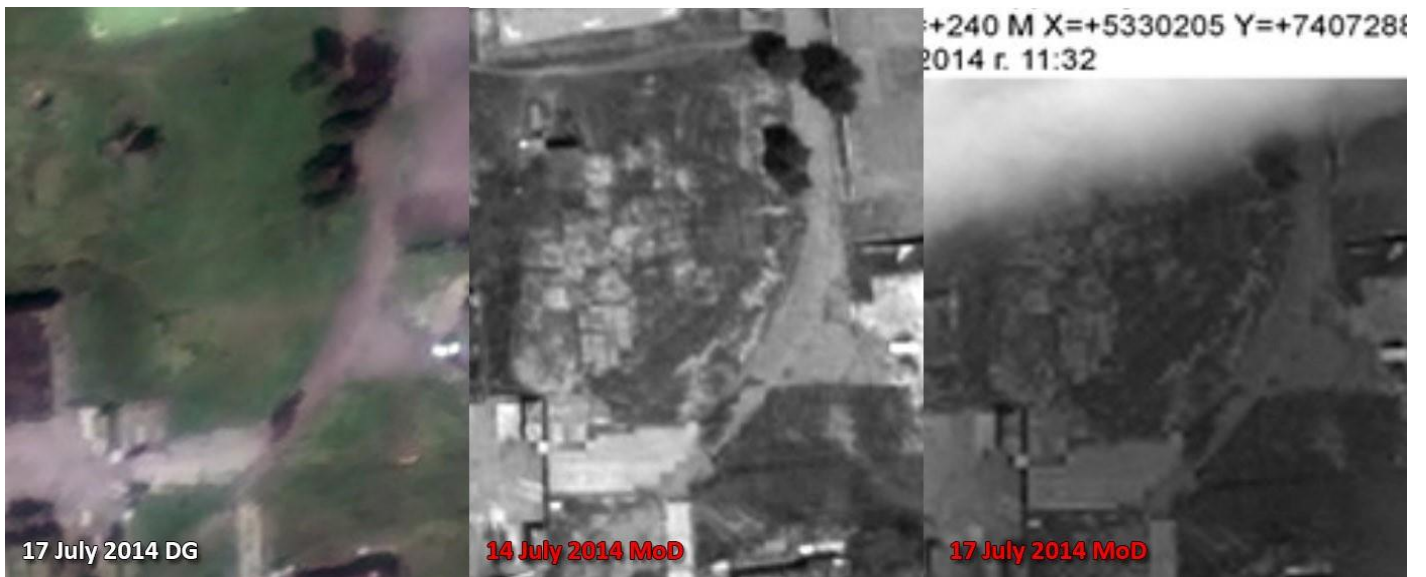
Patches of worn-away grass visible in the Russian Ministry of Defense imagery were also absent in the Digital Globe July 17 imagery.

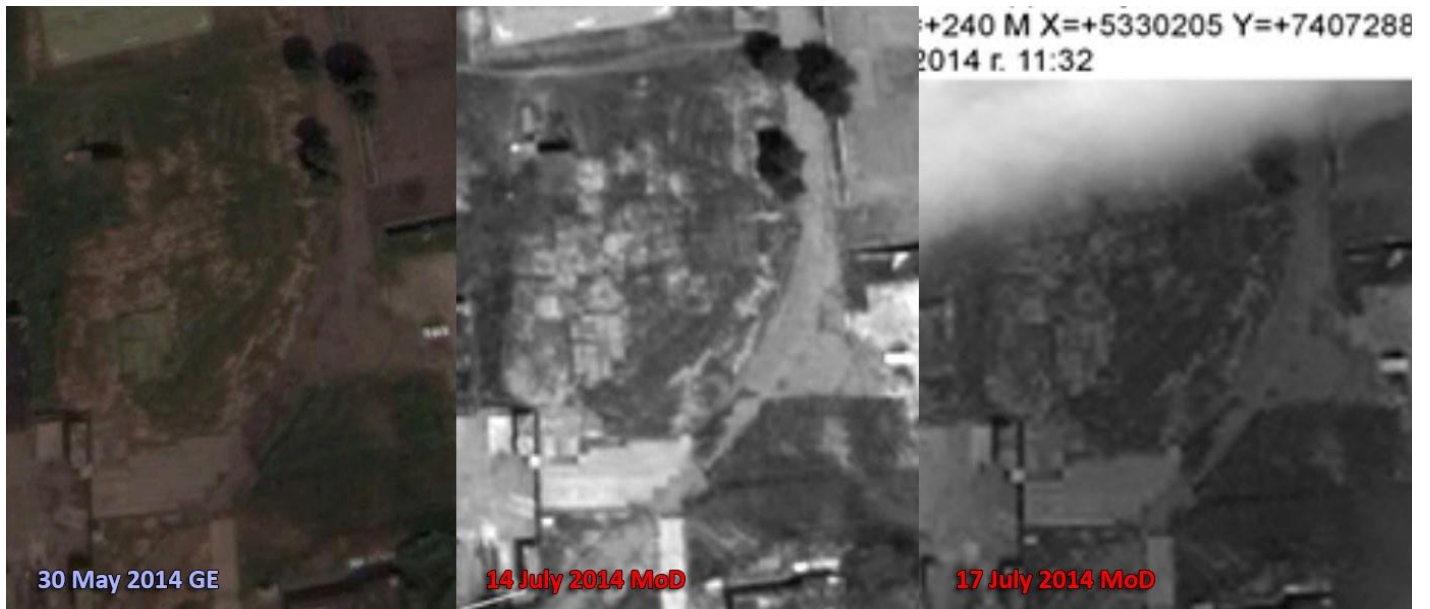
But, as with some of the other discrepancies between the images, the patches of missing grass were visible in earlier historical imagery on Google Earth, clearly showing the Russian Ministry of Defense images were from weeks before MH17 was shot down.

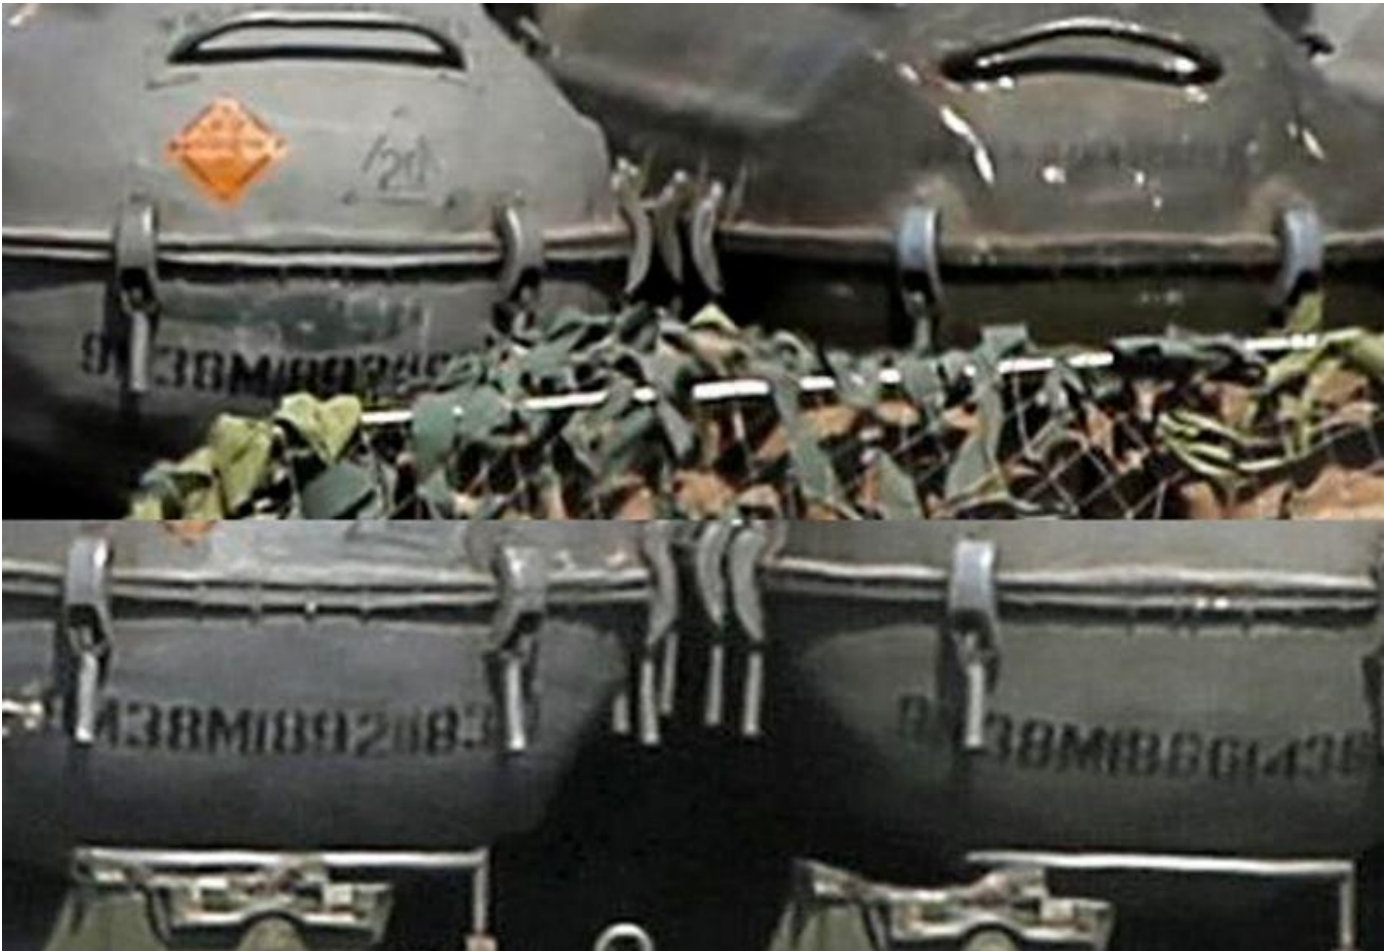
These crates are marked 9M38M1, and it was also possible to identify two vehicles in the Reuters' photographs as being part of the June 23 – 25 53<sup>rd</sup> Brigade convoy transporting Buk 3x2 to Millerovo.<sup>55</sup> It is also possible to identify missiles in videos of the 53<sup>rd</sup> Brigade convoy as having the long tail fins associated with the 9M38M1 missile.<sup>56</sup>
