MH17

The Open Source Investigation
Two Years Later

Introduction

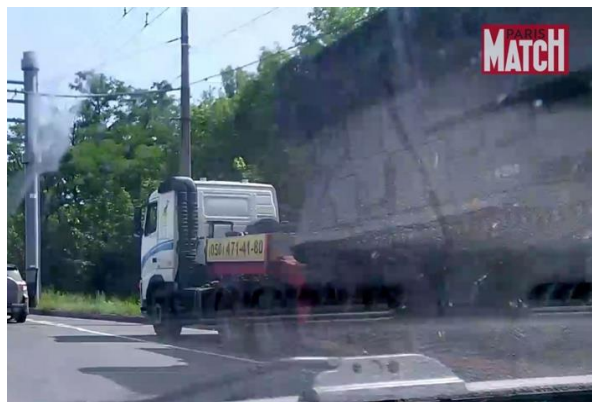
Figure 2: The first Paris Match photograph from Donetsk

The French tabloid magazine *Paris Match* has shared two images^{13 14} showing the Buk in Donetsk. In the first image, a gray 2010 Toyota RAV4—matching the witness account from the “Donetsk is Ukraine!” VK group—is seen ahead of a Volvo truck hauling a Buk-M1 TELAR (Transporter Erector Launcher and Radar). In the second image, various details of the Buk missile launcher are clearer, including the netting above the four mounted missiles.

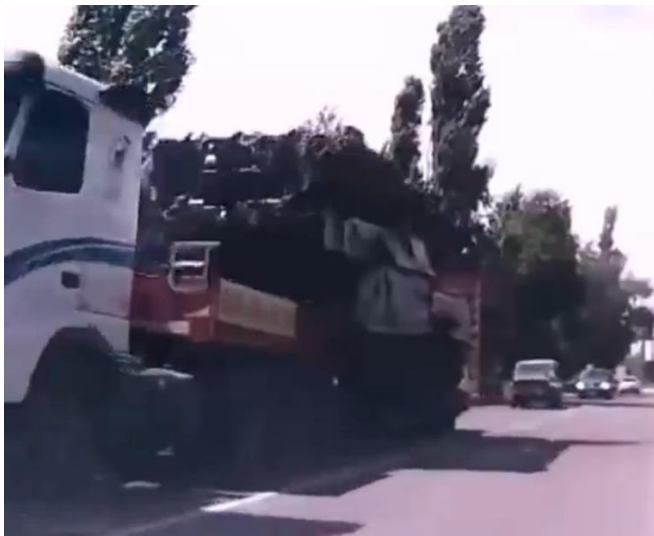
Figure 4: Frame from the video of the Buk missile launcher transported through Makiivka

On May 3, 2016 a video was posted online showing the same Volvo truck transporting the Buk missile launcher in Makiivka, east of the previous sighting in Donetsk.¹⁶

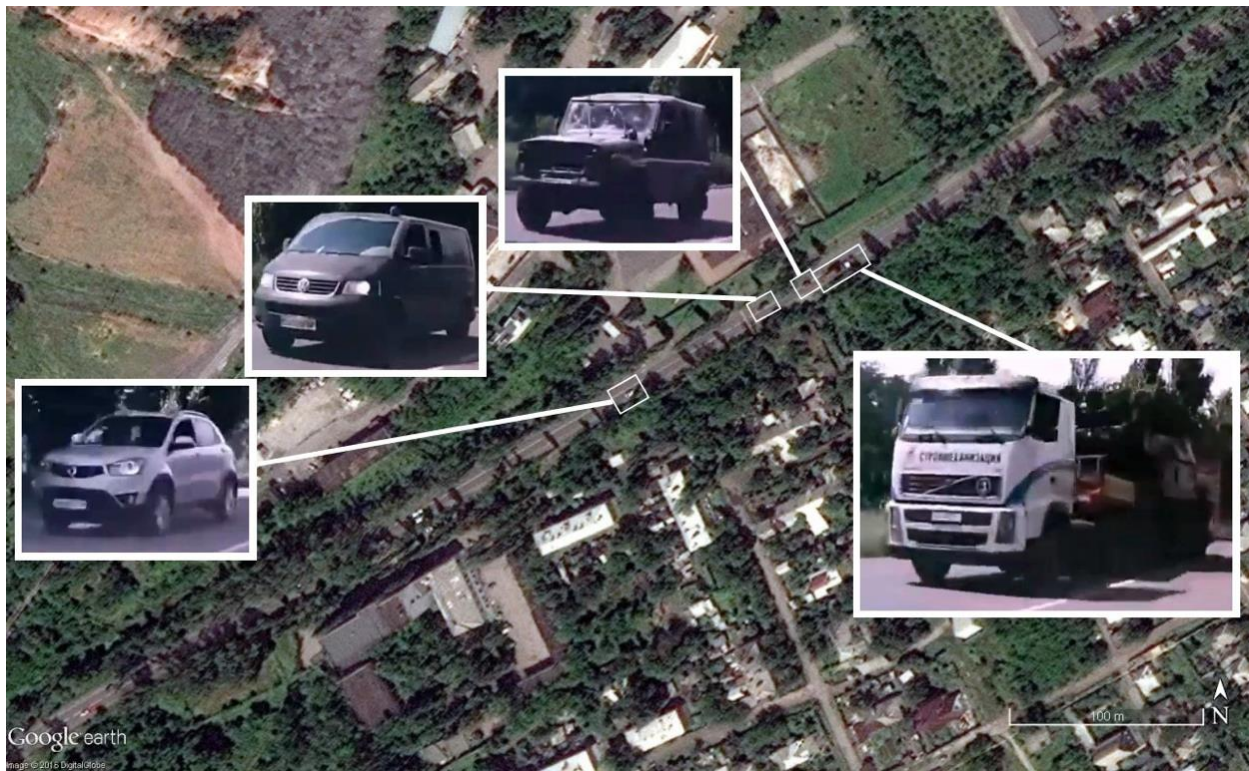
Figure 5: Positions of vehicles in the Makiivka video from satellite imagery dated July 17 2014 (Source - Google Earth/Digital Globe)

On June 22, 2016, Google published satellite imagery from Digital Globe of the area captured on July 17th 2014, showing the truck moving through Makiivka close to the location shown in the video.¹⁷ Based on information from Digital Globe, the satellite image was captured at 11:08am local time.

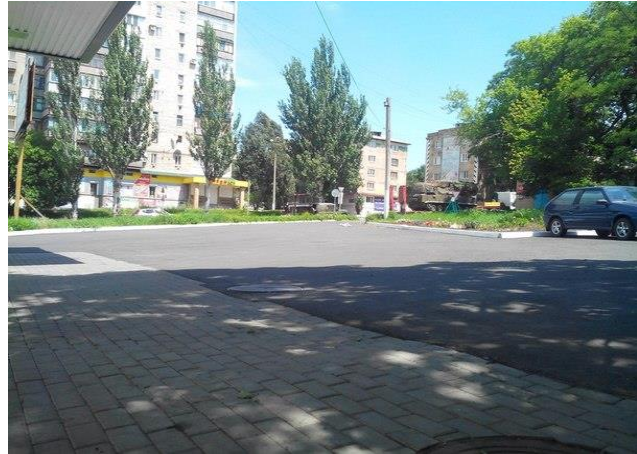
Figure 10: Photograph of a Buk missile launcher transported through Torez on July 17 2014

This photograph, located outside of the StroiDom hardware store in Torez, Ukraine, shows the same Buk missile launcher on the Volvo truck previously seen in the Paris Match images, Makiivka video, and Zuhres video.²⁹ As with the Zuhres video, the location was confirmed by journalists from ARD TV,³⁰ Correctiv,³¹ and 60 Minutes Australia.³² Additionally, journalists from the Guardian³³ and BuzzFeed³⁴ visited the location just days after the downing of MH17 and were able to confirm with locals that a Buk missile launcher traveled through this location just after noon on July 17.

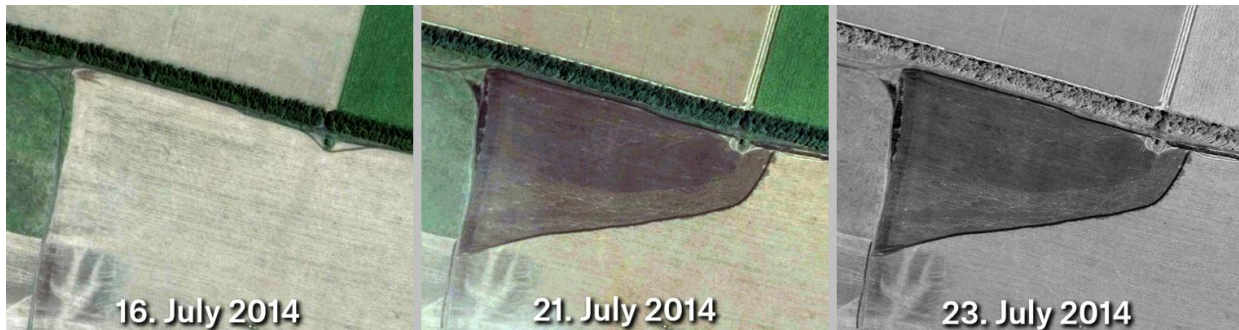
Figure 14: Field south of Snizhne between July 16 and 23 (Source Google Earth/Digital Globe)

Looking to the launch site itself, journalists Christopher Miller and Roland Oliphant visited⁵⁰ the field south of Snizhne on July 22, 2014. The two found a burned field with various pieces of debris, including a piece of plastic from a weapons container manufactured by Steklo Plastik, which had its offices raided of approximately \$25,000 worth of equipment by separatist soldiers about three weeks before the downing of MH17. Christopher Miller spoke with a resident of Chervonyi Zhovten, the nearest village from the field, who said that he saw and heard a missile launch from the field immediately before the downing of MH17.

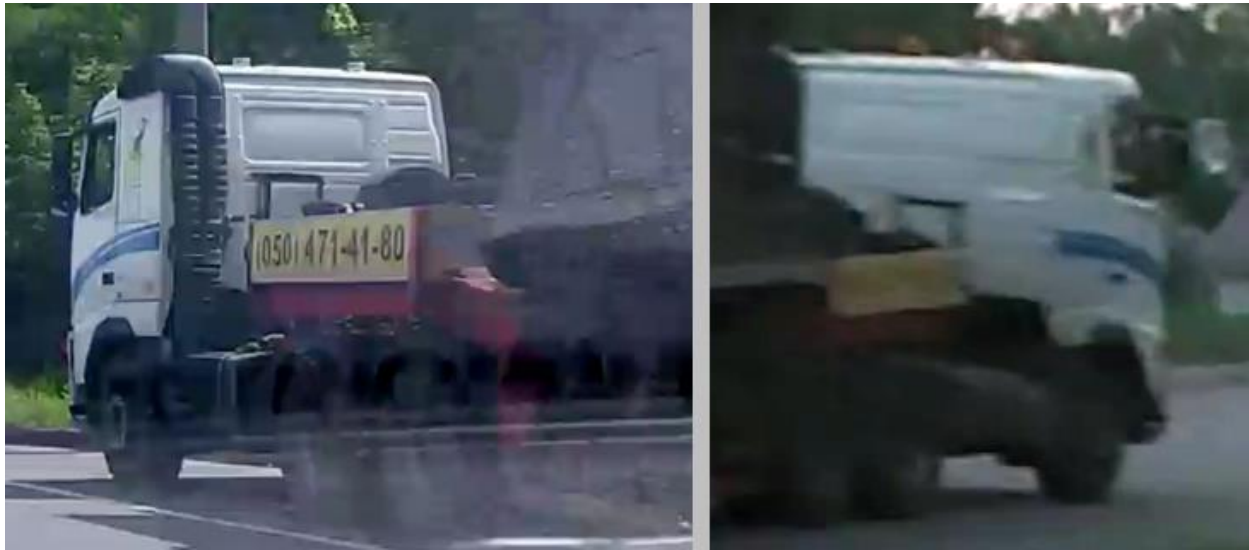
Figure 18: Comparison of the truck in the Donetsk Paris Match photographs (left) and Luhansk video (right)

Other than the Buk itself, the most obvious similarity to this video and the previous photographs and videos of the Buk in Ukraine is the white Volvo with red low-loader. This Volvo truck is hauling the Buk missile launcher in all of the sightings in eastern Ukraine on July 17, except after the Buk was unloaded in Snizhne. The truck can be recognized by the phone number on the red low-loader, the yellow Stroymekhanizatsiya elephant logo on the cabin, a blue stripe across the doors, and orange siren lights on top of the white cabin.

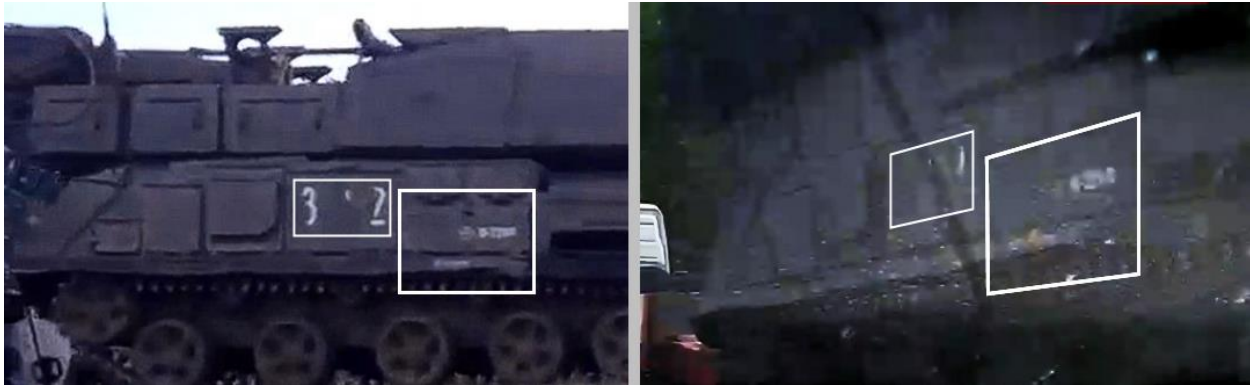
Figure 21: Markings on Buk 3x2 filmed in Russia in June 2014 (left) and markings from the Buk in the Donetsk Paris Match photographs (right)

This Buk has many similarities with the one photographed and filmed in Ukraine on the day of the MH17 downing. This Buk seen in Russia was dubbed “3x2” due to an obscured number on the side of the vehicle. Since early investigations, we have been able to determine that this Buk was originally numbered 332 after comparing the various characteristics from photographs and videos going back to 2010.⁶² The remaining fragments of the numbers of the Buk seen in the Paris Match images, as well as the railway transport markings, center of gravity mark, white paint on the rubber side skirt, and other features were in the exact same positions.⁶³

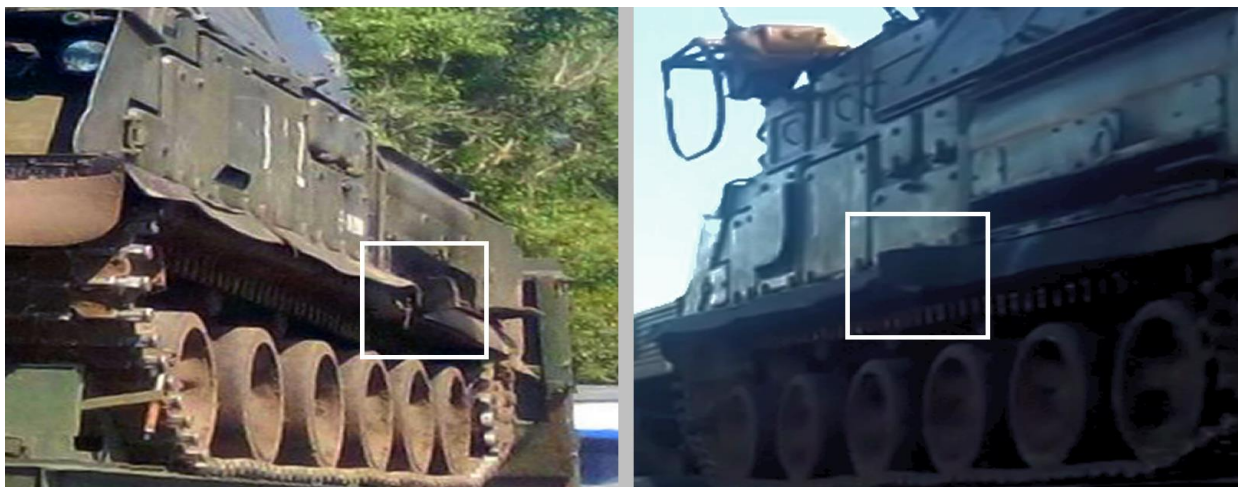
Figure 25: Damage to the side skirt visible on Buk 3x2

This tear on the rubber side skirt can be identified in the exact same location on the Buk seen in Ukraine. Over the past two years, members of the Bellingcat investigation team have compared the features of Buk 332, seen both in Russia and Ukraine in the summer of 2014, with every other Buk photographed or filmed in 2013 and 2014 in Russia and Ukraine discovered by investigators. No other Buk has even half of the same details seen on this Buk, including the number, exact placement of the various white marks, the side skirt “fingerprint”
